## September 2024 Boris Flood in CEE

**PIU Seminar**

Warszawa

9 June 2025

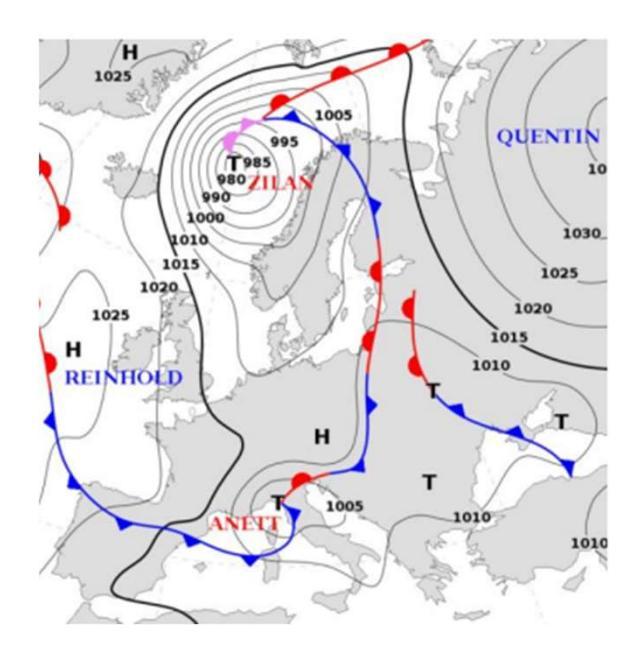
Primary synoptic feature associated with the event was the low-pressure system Boris/Anett.

It developed in central Mediterranean and stalled over Central Europe. Extreme amount of rain fell over a large area in a 5-day period from September 12 to 16.

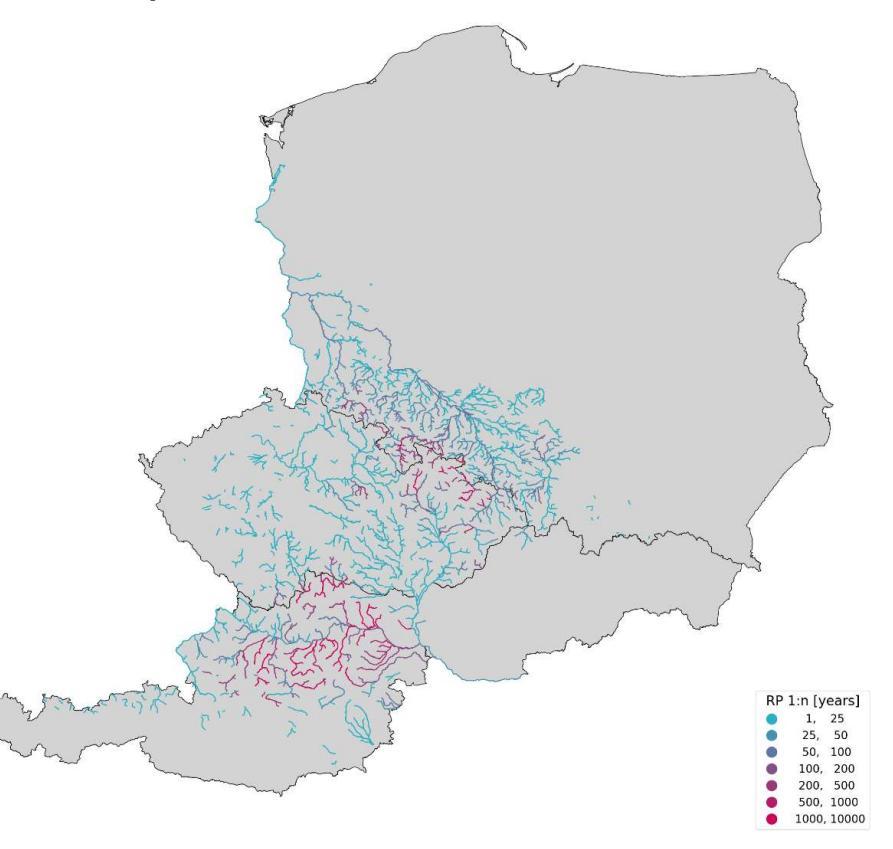
#### Event footprint reconstructed based on observed river flows

- Significant damage occurred in parts of the Czech Republic, Poland and Austria.
- In the Czech Republic, the most affected areas were in the Opava, Odra and upper Morava catchments, with rainfall accumulations that exceeded 500 mm.
- In southwest Poland, flooding occurred in the Nysa Kłodzka basin and upper Odra.
- In Austria, widespread damage occurred particularly in Lower Austria.
- Additional impacts were reported from west Slovakia, as well as from parts of Romania.

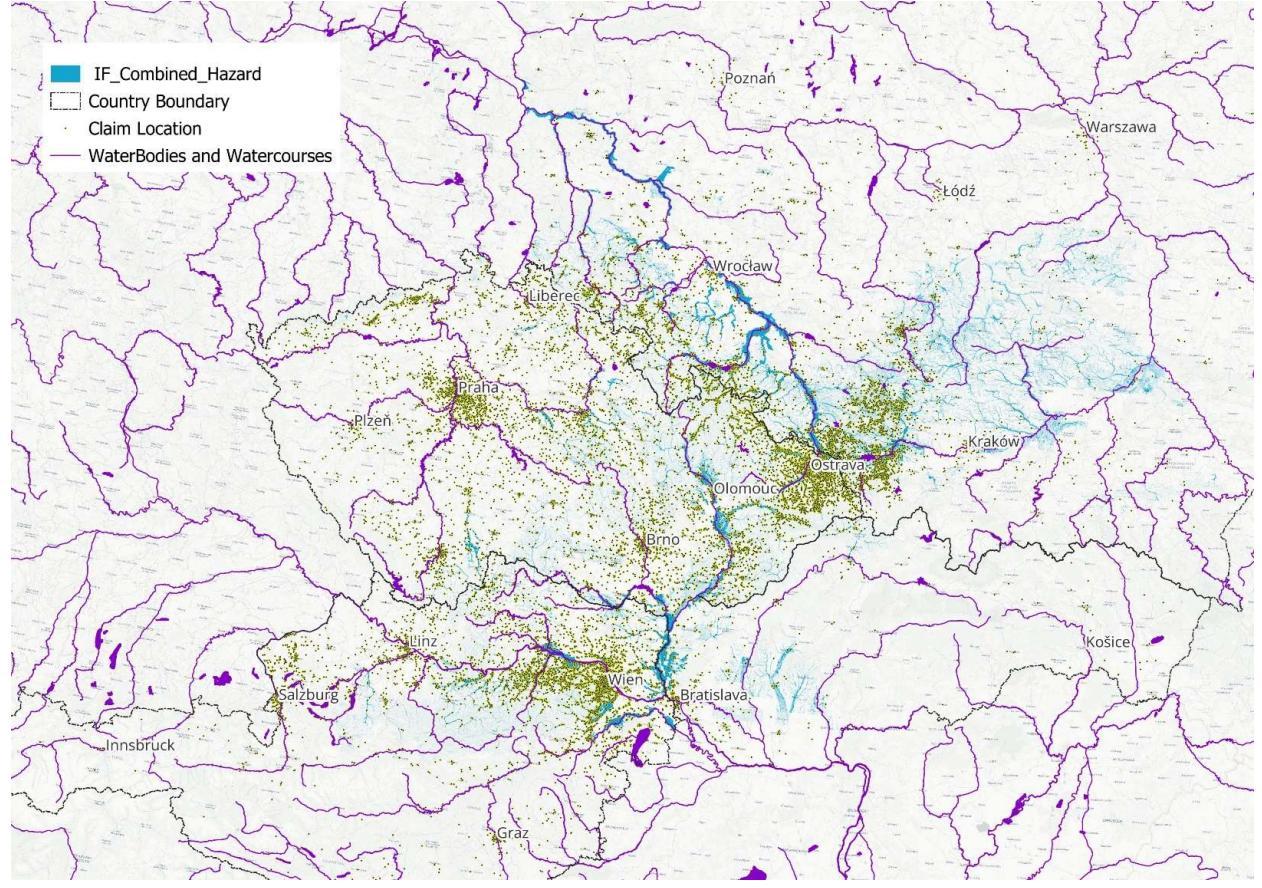
- Spatial distribution of claims is in line with modelled flood extent.
- Claims in cities, that were not flooded (Prague, Brno, Warszawa) probably show place of policy holder but not flooded property.

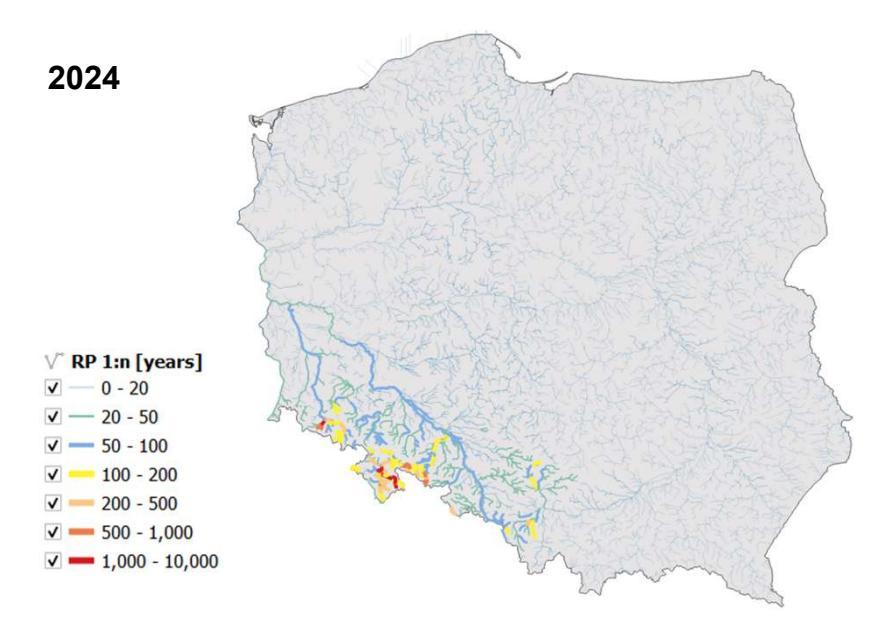
#### 2024 water levels reached new records at several places

- 1. Nysa Kłodzka river in Kłodzko 150 cm above record water level from 1997.
- 2. Wilczka river in Międzygórze 33 cm above record water level from 1997.
- 3. Morawka river with dry polder in Stronie Śląskie the polder collapsed on Sep 15.
- 4. Odra river in Krzyżanowice 43 cm above record water level from 1997.

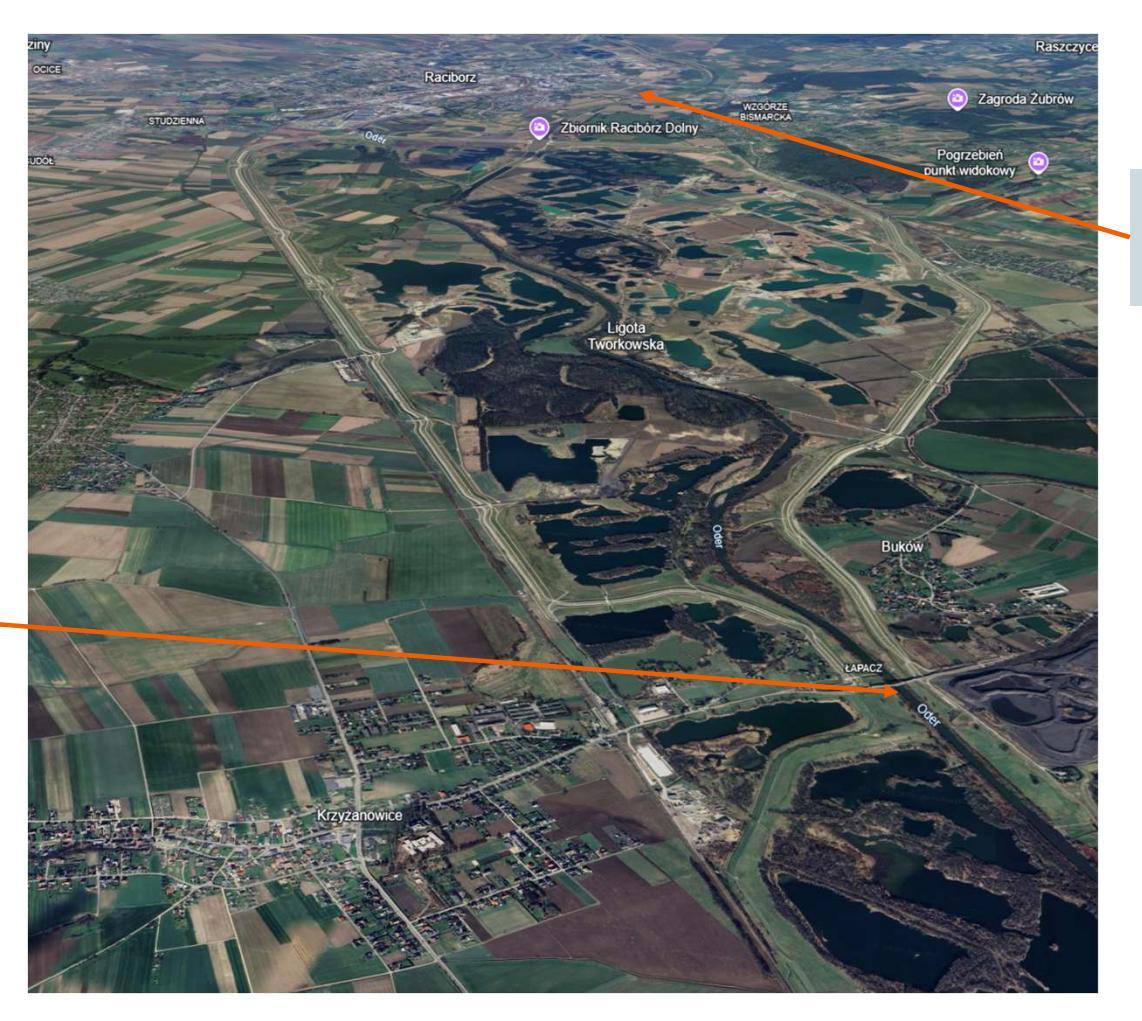
### Effect of Polder Racibórz Dolny

**Racibórz-Miedonia** (downstream): peak water level 801 cm = 244 cm below peak in 1997

**Krzyzanowice** (upstream): peak water level 955 cm = 43 cm above peak in 1997

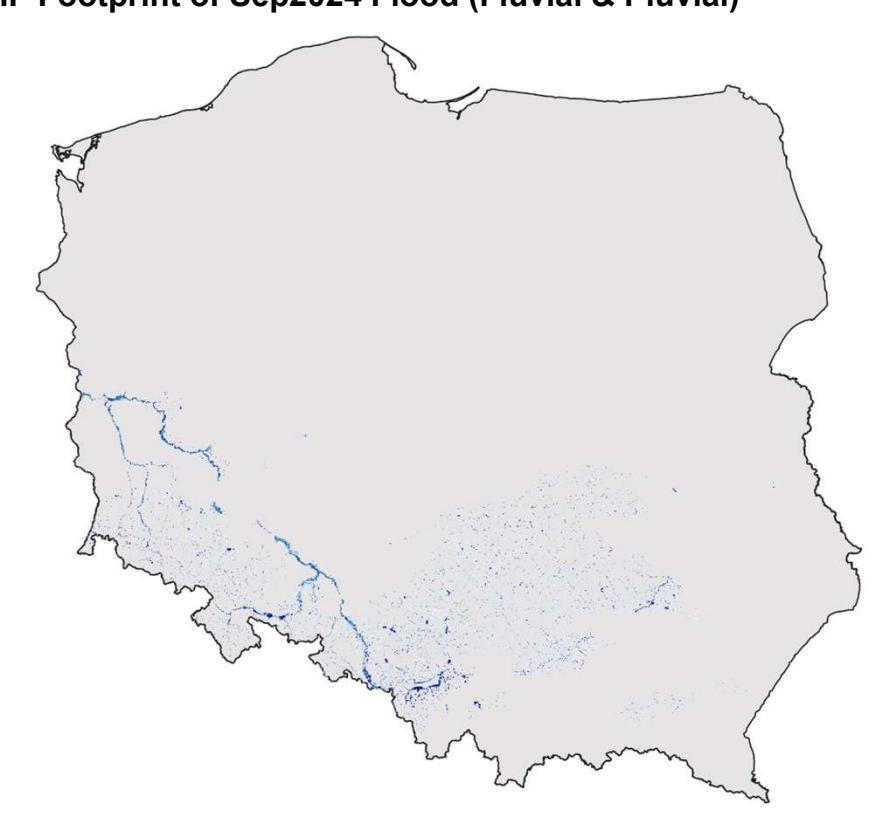
#### IF Footprint of Sep2024 Flood (Fluvial & Pluvial)

- Modelled flood loss for Polish market: 1.319bn PLN
- Return period of modelled loss varies per company between 13-36 years.

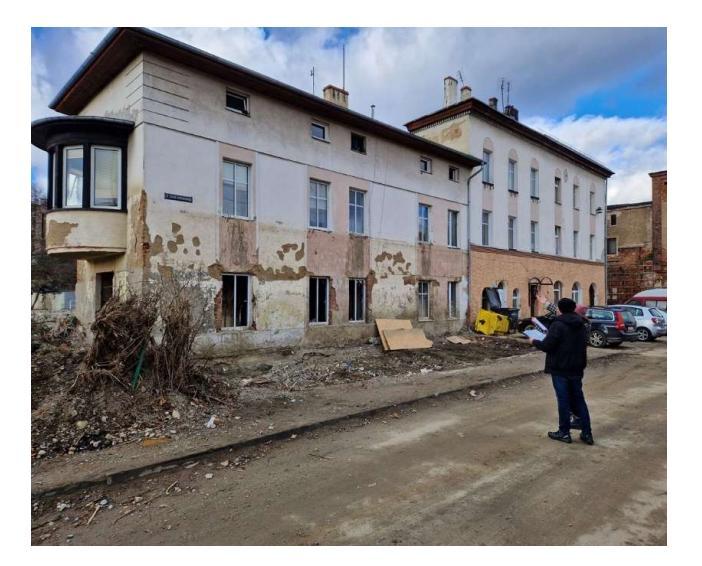
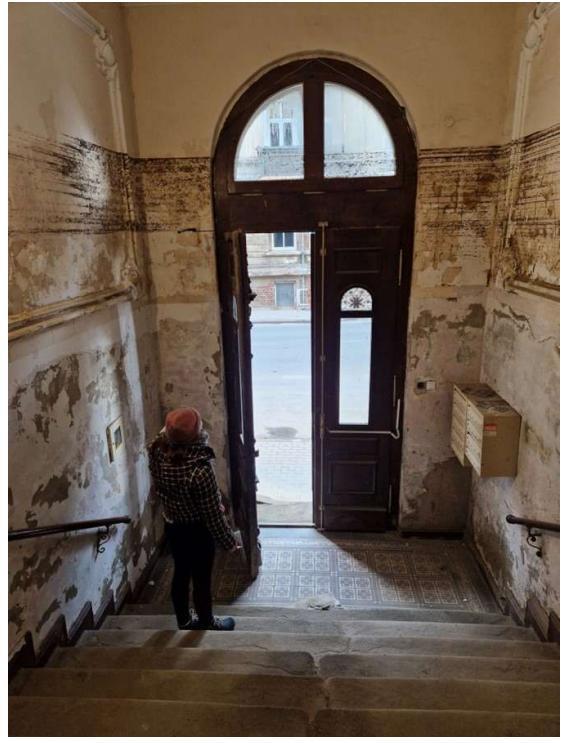
#### Damage Assessment Kłodzko, Poland

- The predominant damage mechanism observed is related to contact with water.
- Debris impacts are an additional source of structural damage to buildings located near the river.
- Water level near the river was very high, reaching up to 4.5 meters.
- Even in buildings situated further from the river (approximately 100 meters away), watermarks are visible at a height of around 2.5 meters.
- Most buildings located near the river experienced moderate to substantial structural damage.
- Buildings located further from the river experienced either no structural damage or minor damage.
- Structural damage to buildings correlates with the initial condition of the buildings.

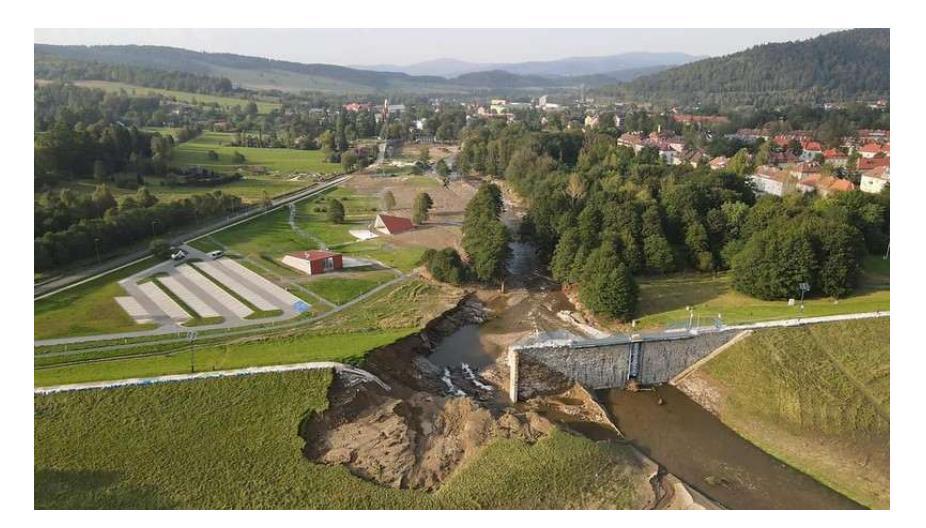
#### Stronie Śląskie dry polder

- 16 meters high
- Built between 1906 and 1908 to contain the frequent flooding caused by the Morawka River
- Built to withhold 70-80 m<sup>3</sup>/s
- Flood wave 320 m<sup>3</sup>/s

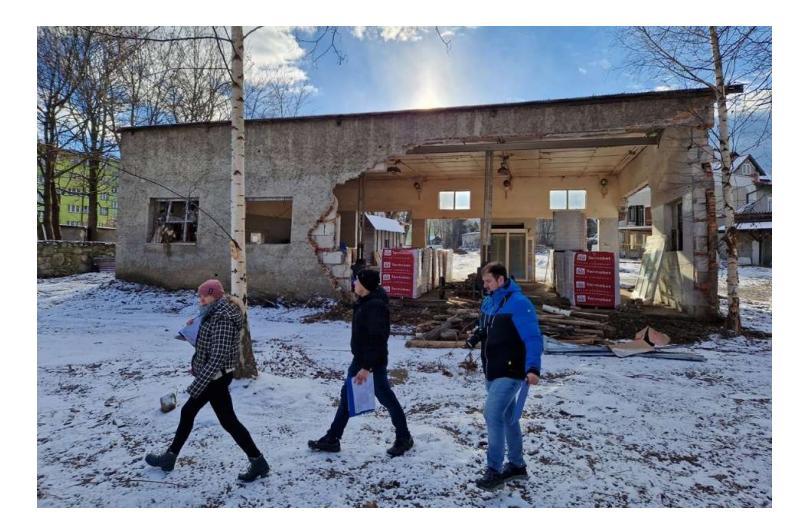
- Watermarks noted at heights from 0.5 m to 3 m, depending on building locations.
- Several buildings fully destroyed.
- Multiple appurtenant structures destroyed.
- High water density indicated by mud levels inside buildings.
- Bridge sustained significant damage.

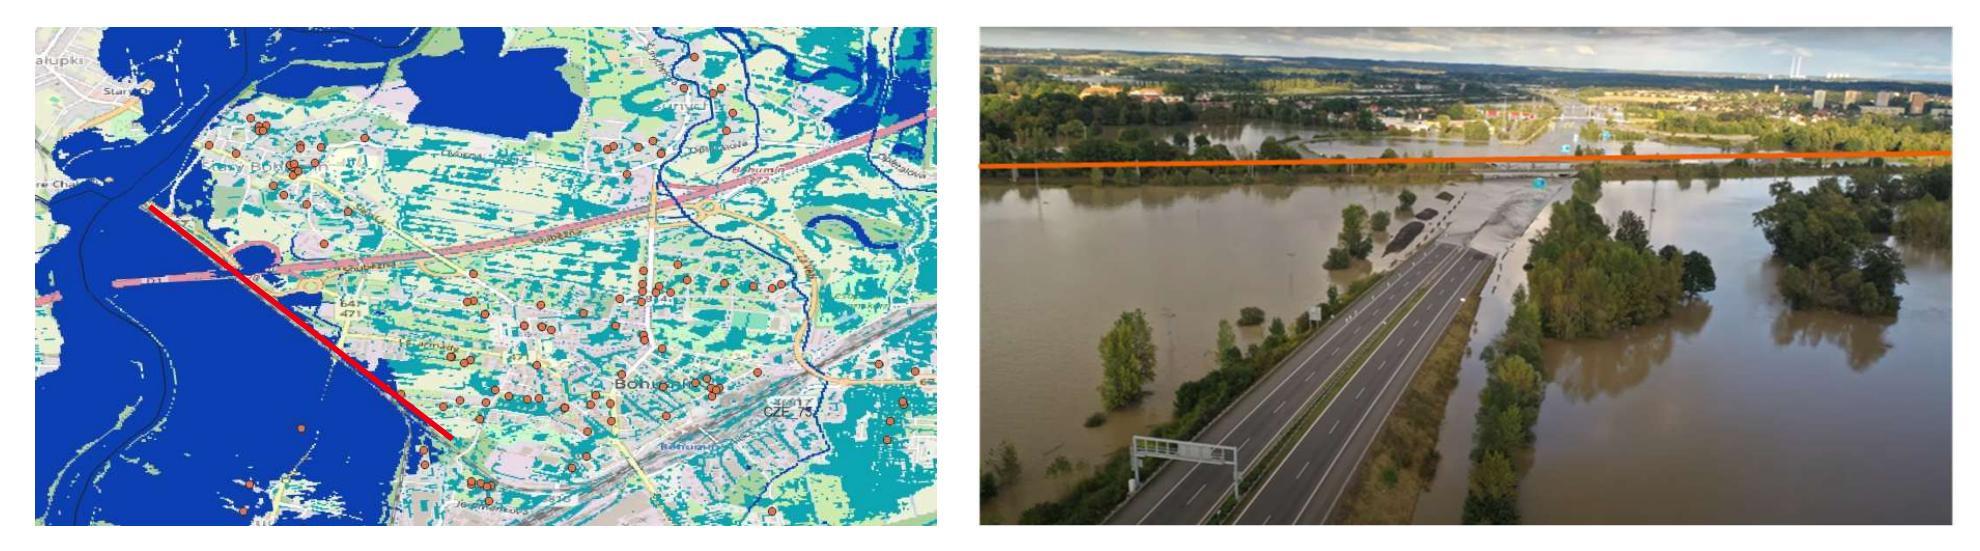
### **Next Step – Final Flood Extents**

Bohumín – the railway barrier works in the model as real barrier while, in reality, flood overcame it and the extent spread further east.

- As of now (spring 2025), local hydrological offices are working on projects to evaluate the flood. Peak flows and peak water levels are being verified because during a flood the gauging stations may measure incorrect values.
- Once the verified hydrological data is published, IF model developers will use the data together with other information that was not available during the flood event (dam breaks, levee failures, water reservoirs being emptied before the flood) and will create final flood footprints.
